Snow Avalanches Along Colorado Mountain Highways

by Hans Frutiger

ROCKY MOUNTAIN FOREST AND RANGE EXPERIMENT STATION

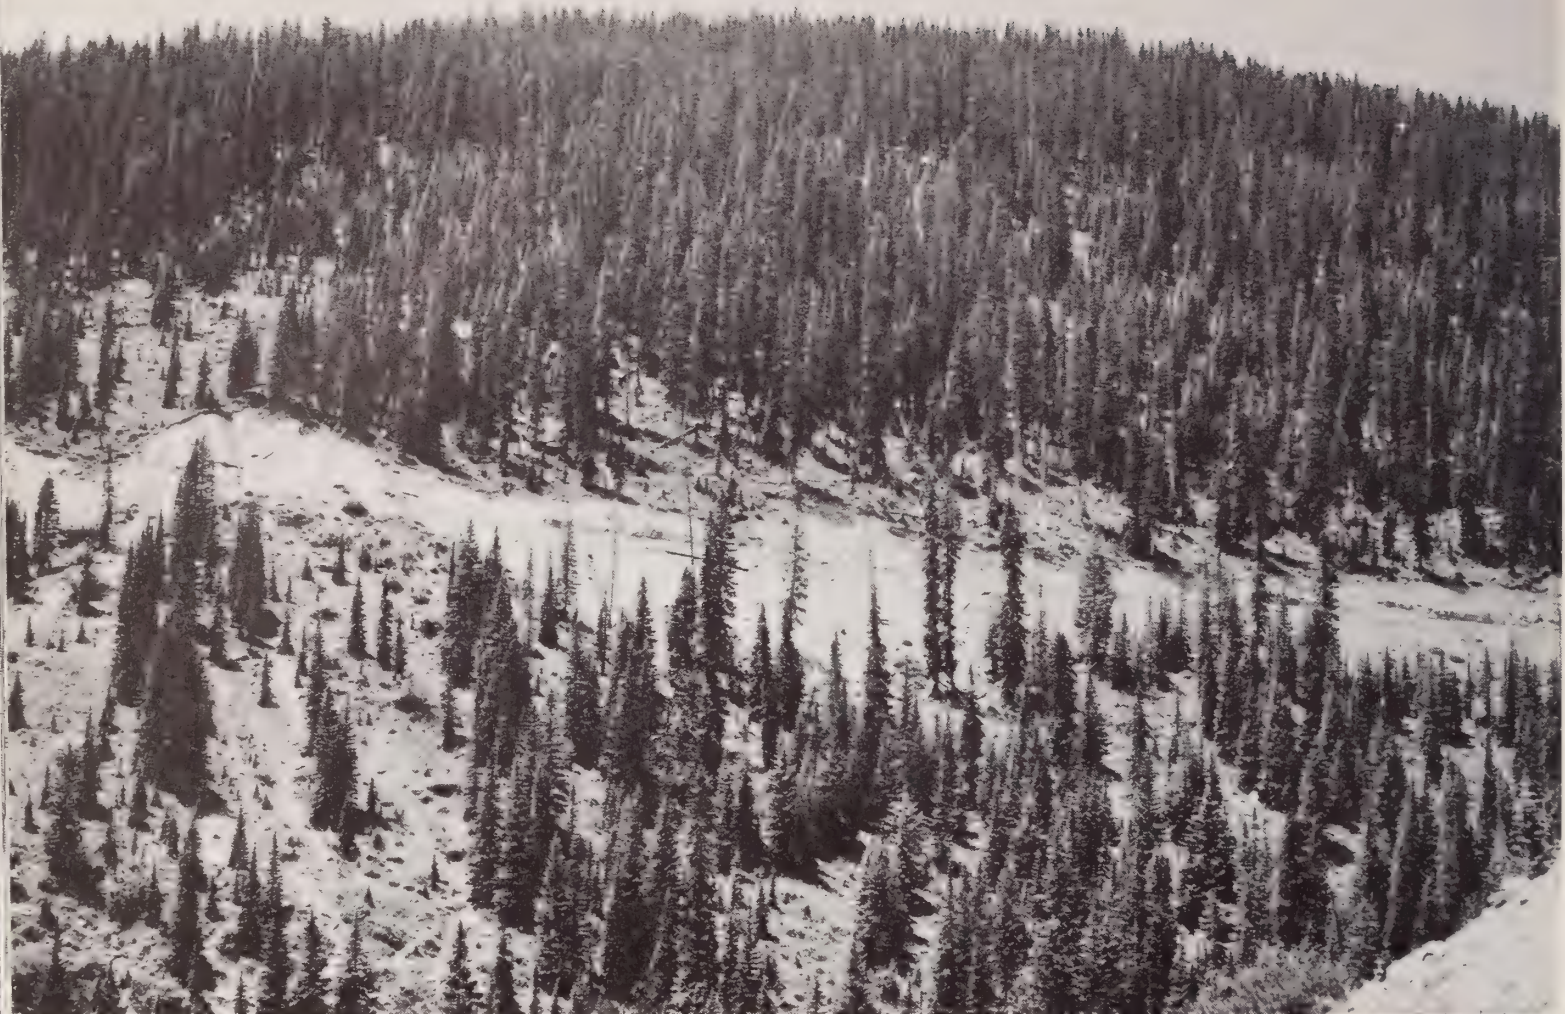
COAL CREEK (C-2)

Highway No. 550 --
Coal Bank Hill
Photo: July 4, 1962

Control is principally a matter of afforestation. On steep slopes, supporting structures would help to protect both the highway and the young trees.

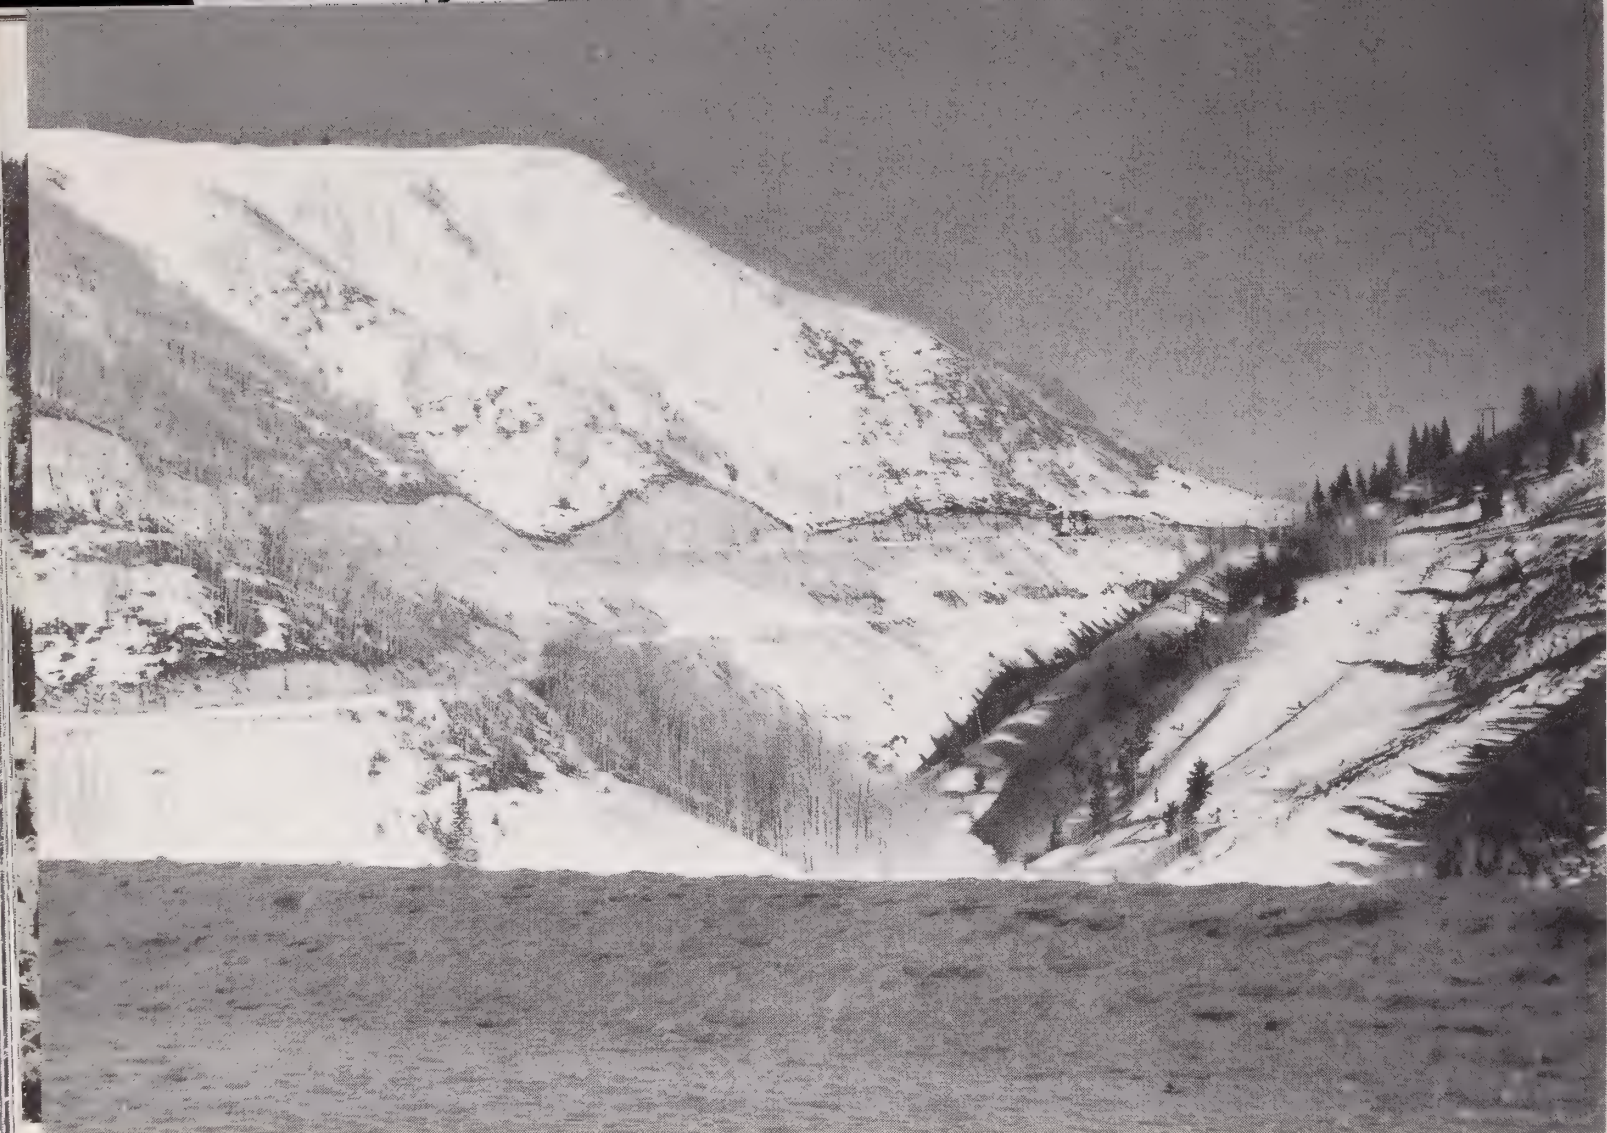
SPRINGS (OR WATERFALLS) (M-1)

Highway No. 550 --
Molas Divide
Photo: January 3, 1962

Use of supporting structures is unlikely when extent of catchment basin and erratic occurrence of avalanches dangerous to the highway are considered. The gentle slope below 10,600 feet m.s.l. is favorable for diversion, retarding, or catchment structures.

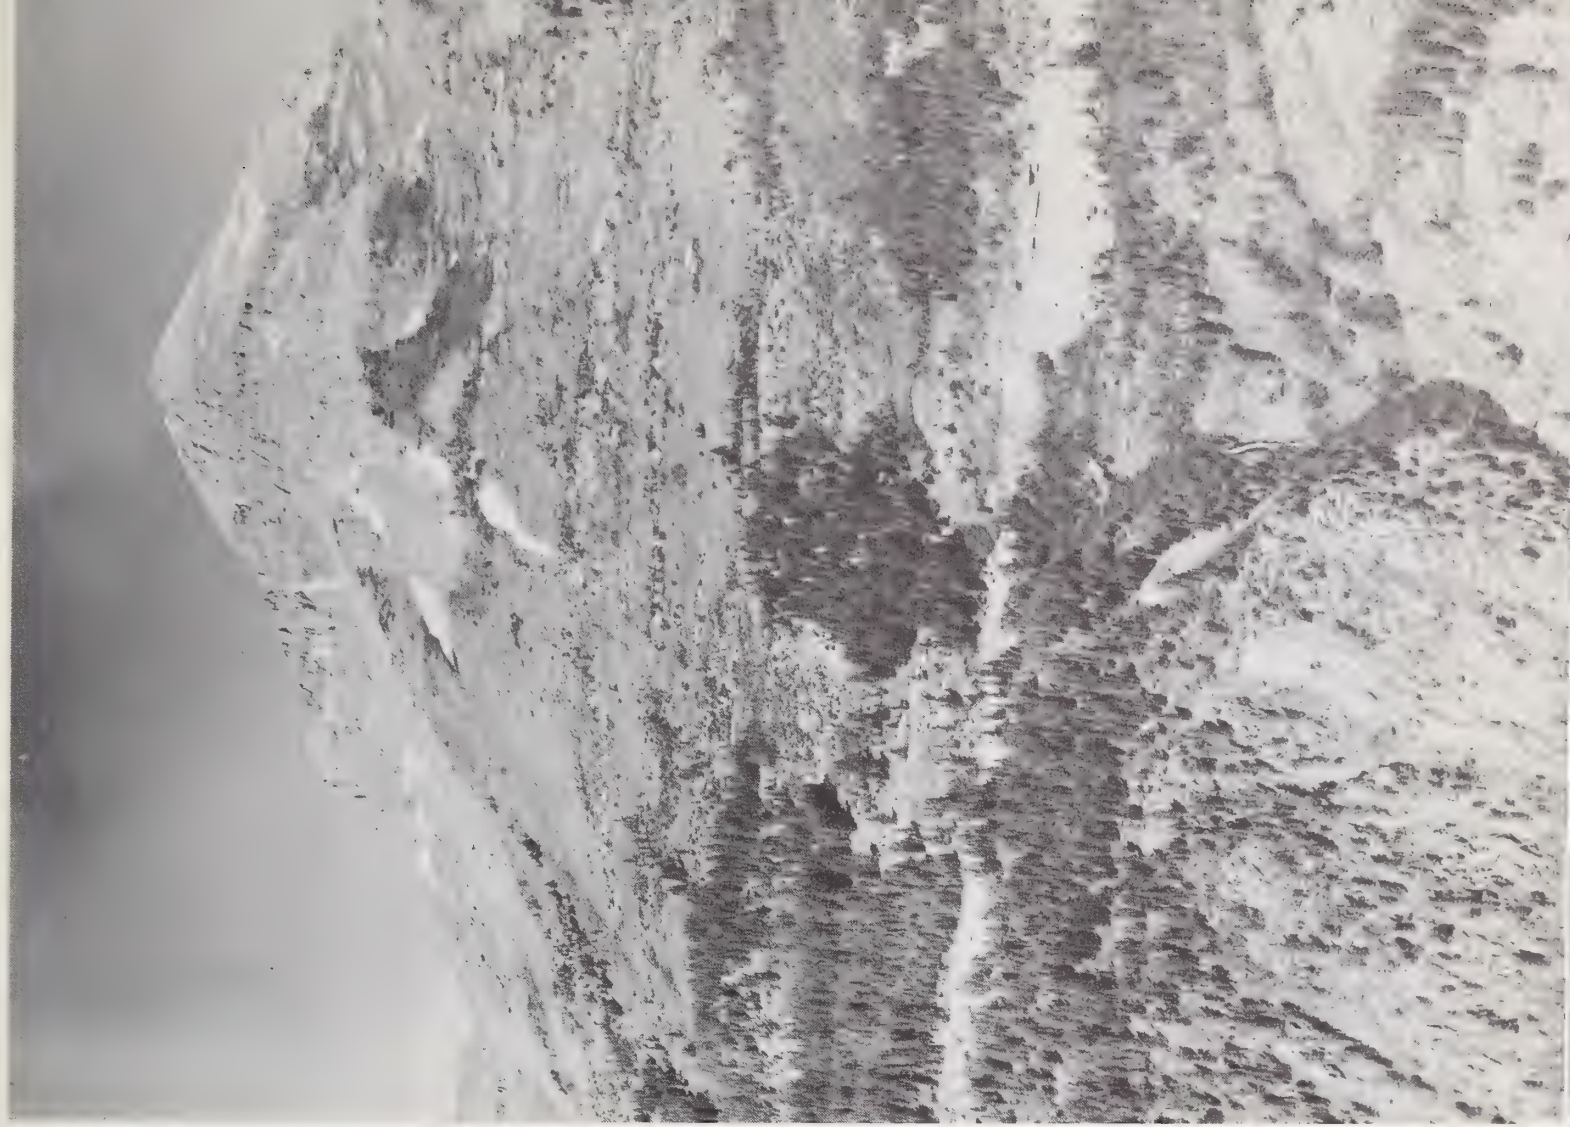
DEADWOOD (M-3)

Highway No. 550 --
Molas Divide
Photo: July 4, 1962

Terrain and vegetation conditions are favorable for supporting structures.

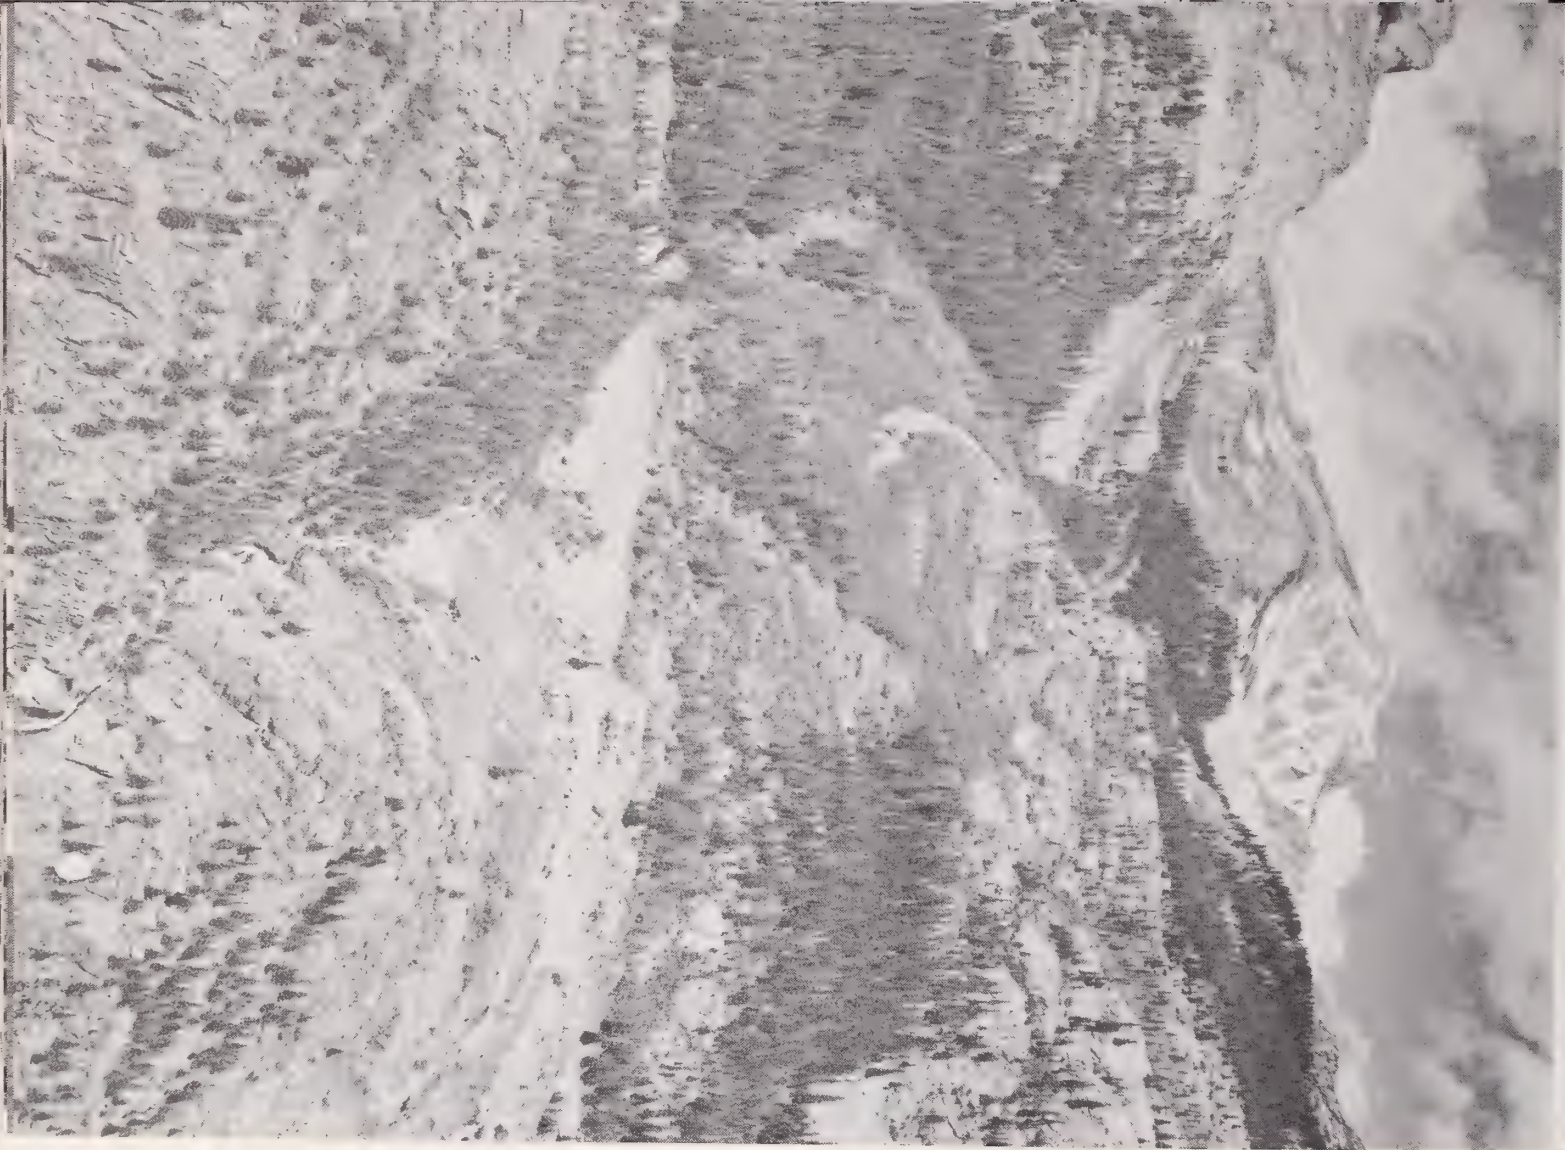
CHAMPION (M-4)

Highway No. 550 --
Molas Divide
Photo: July 4, 1962

Terrain conditions are favorable for installation of supporting structures. Some field checks needed to locate starting spots.

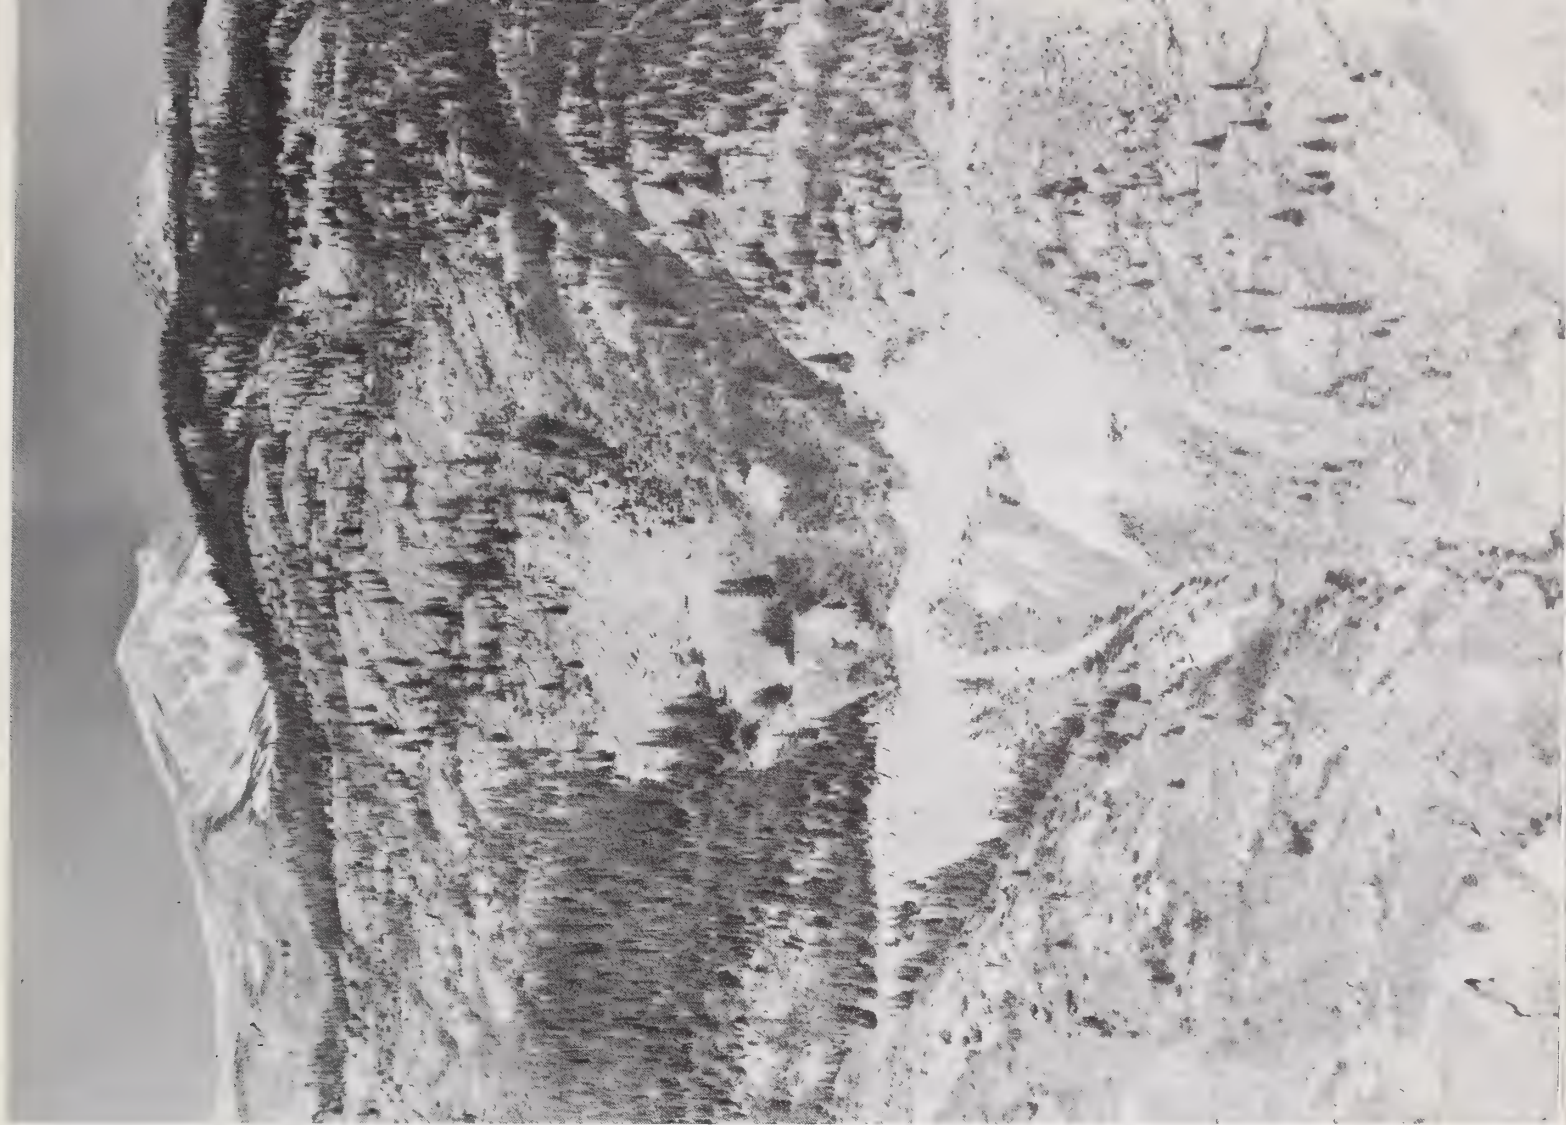
PEACOCK (M-5)

Highway No. 550 --
Molas Divide
Photo: July 4, 1962

Supporting structures until aisle is afforested and avalanche is eliminated.

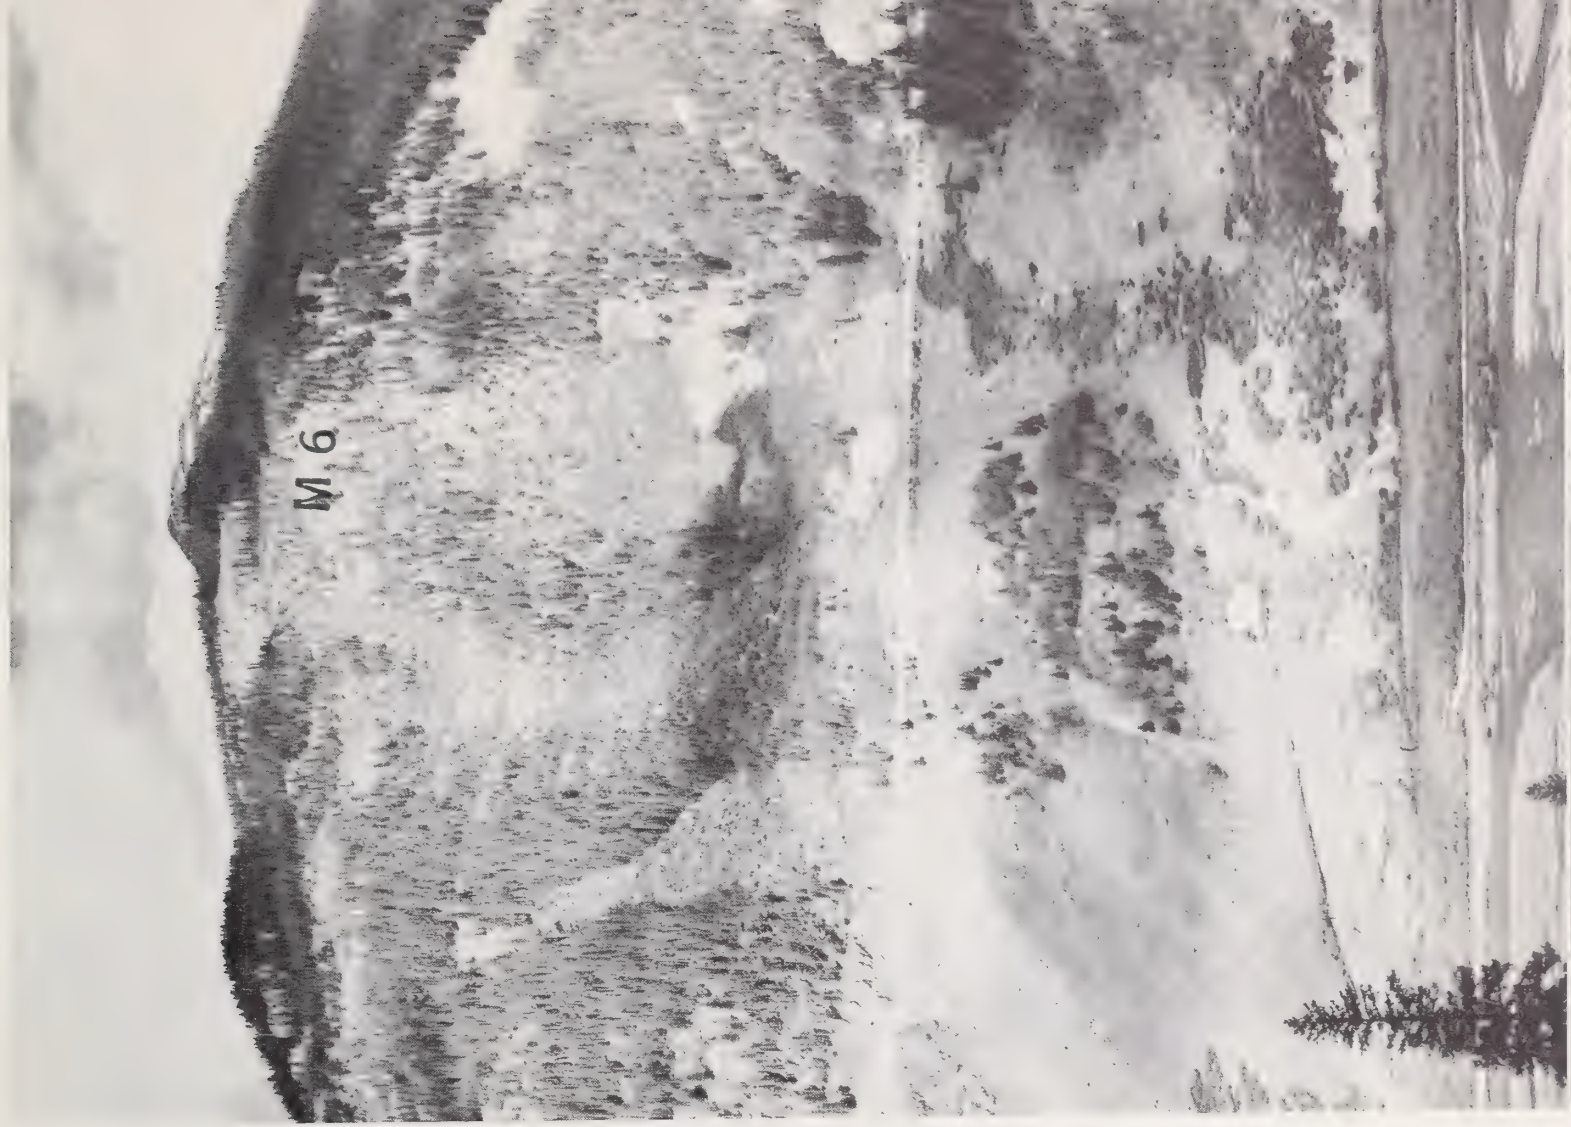
JENNIE PARKER (M-6)

Highway No. 550 --
Molas Divide
Photo: March 24, 1962

Because starting spots lie below timberline in a generally timbered area, control appears to be by supporting structures and afforestation. Starting spots are very indefinite and some cliffs may cause trouble, however. If careful field checks indicate that timber could be expected to come in after slides were controlled, then supporting structures would be recommended. If prospects for revegetation were poor, an avalanche shed would be best control method.

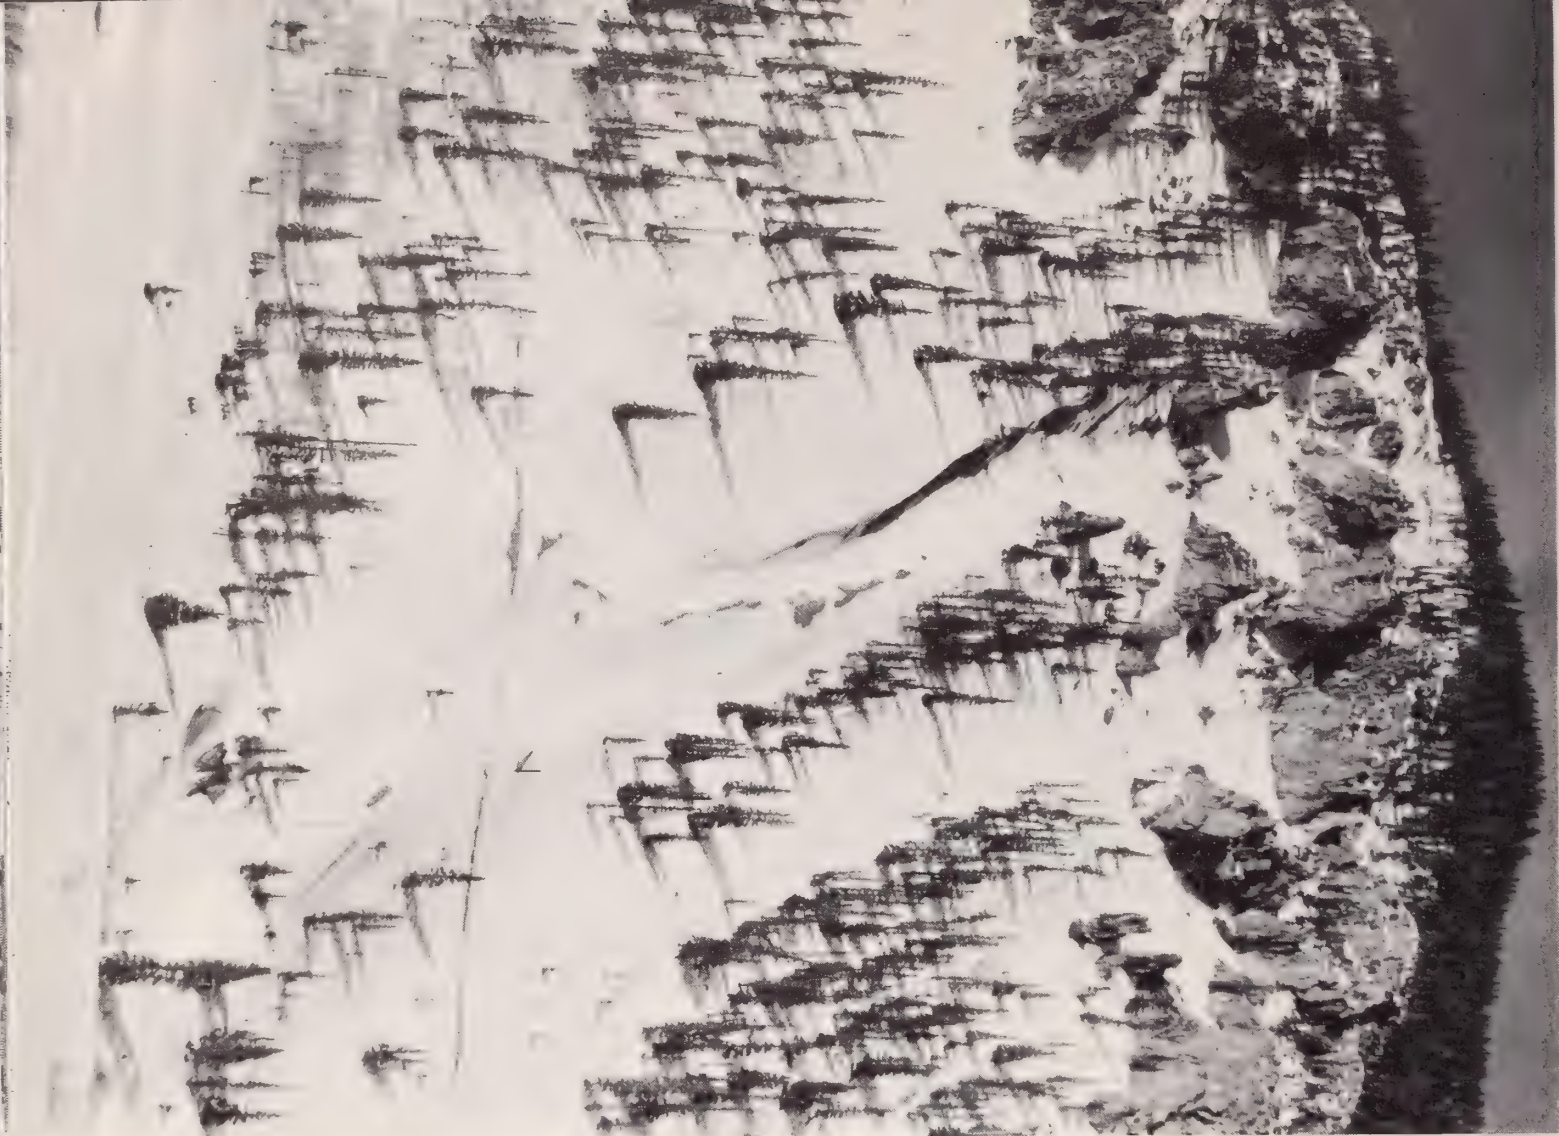
PI7 (R-3)

Highway No. 550 --
Red Mountain Pass
Photo: March 25, 1962

Runs very seldom, but when it runs, very big snow masses with much debris are expected. If control is desired, the only possibility would be an avalanche shed.

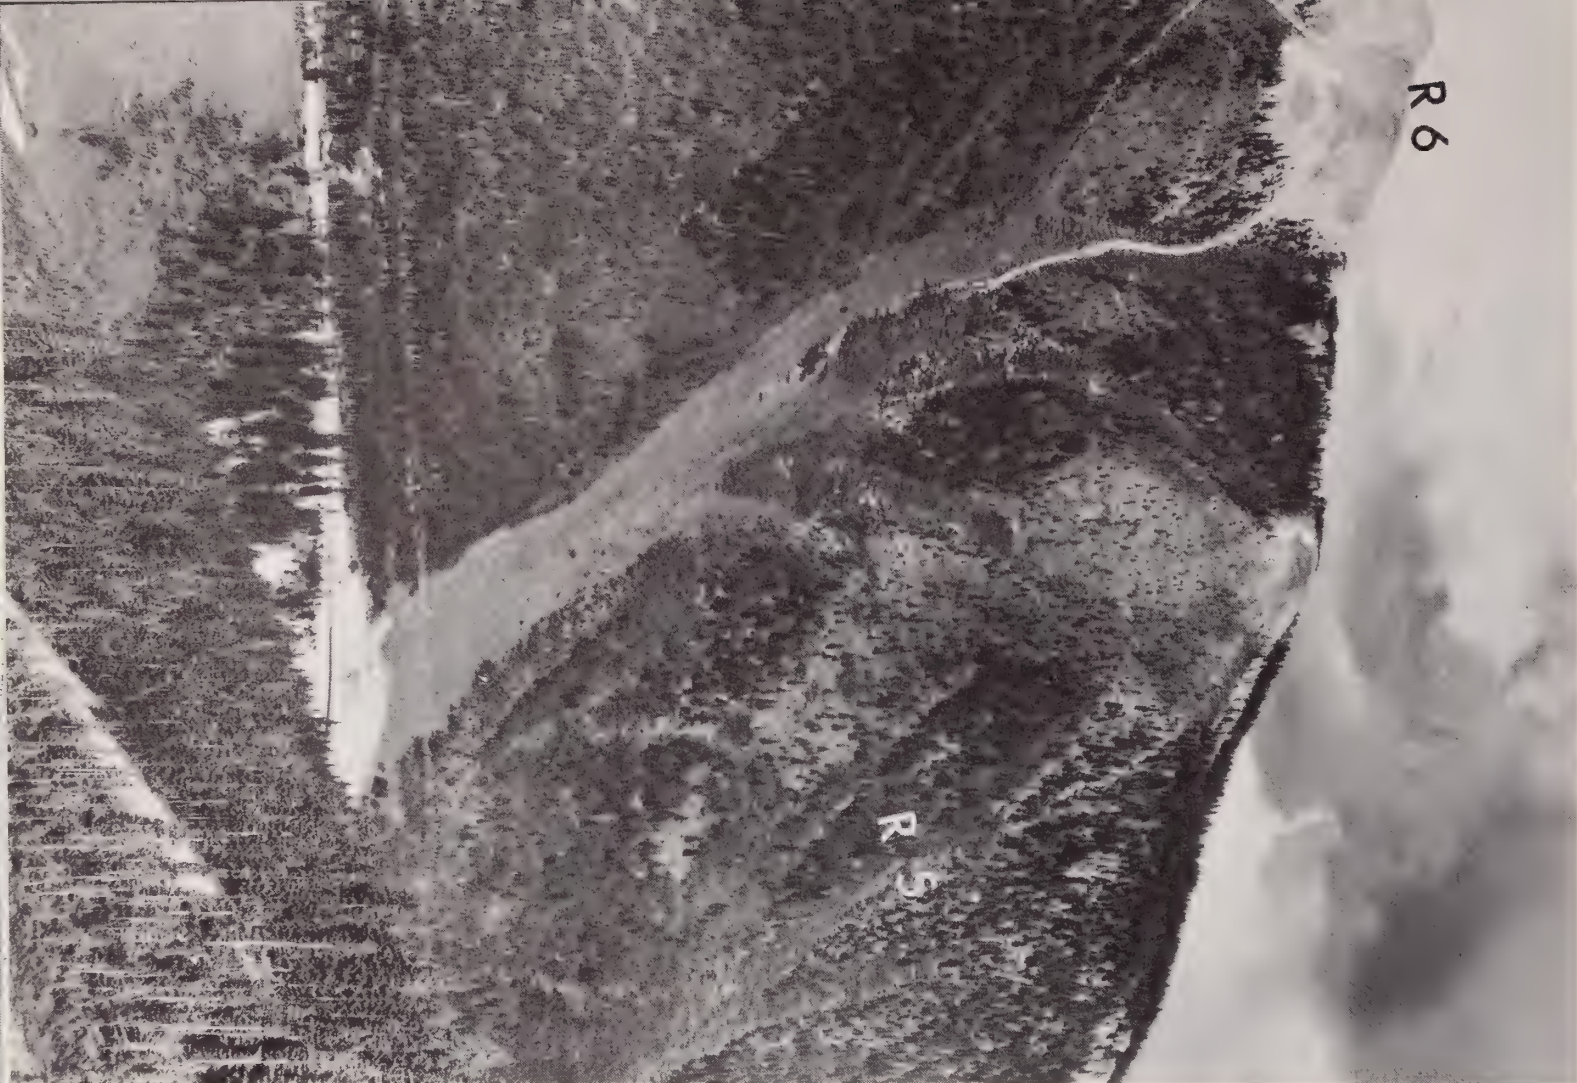
LOWER CEMENT FILL (R-5)

*Highway No. 550 --
Red Mountain Pass
Photo: July 3, 1962*

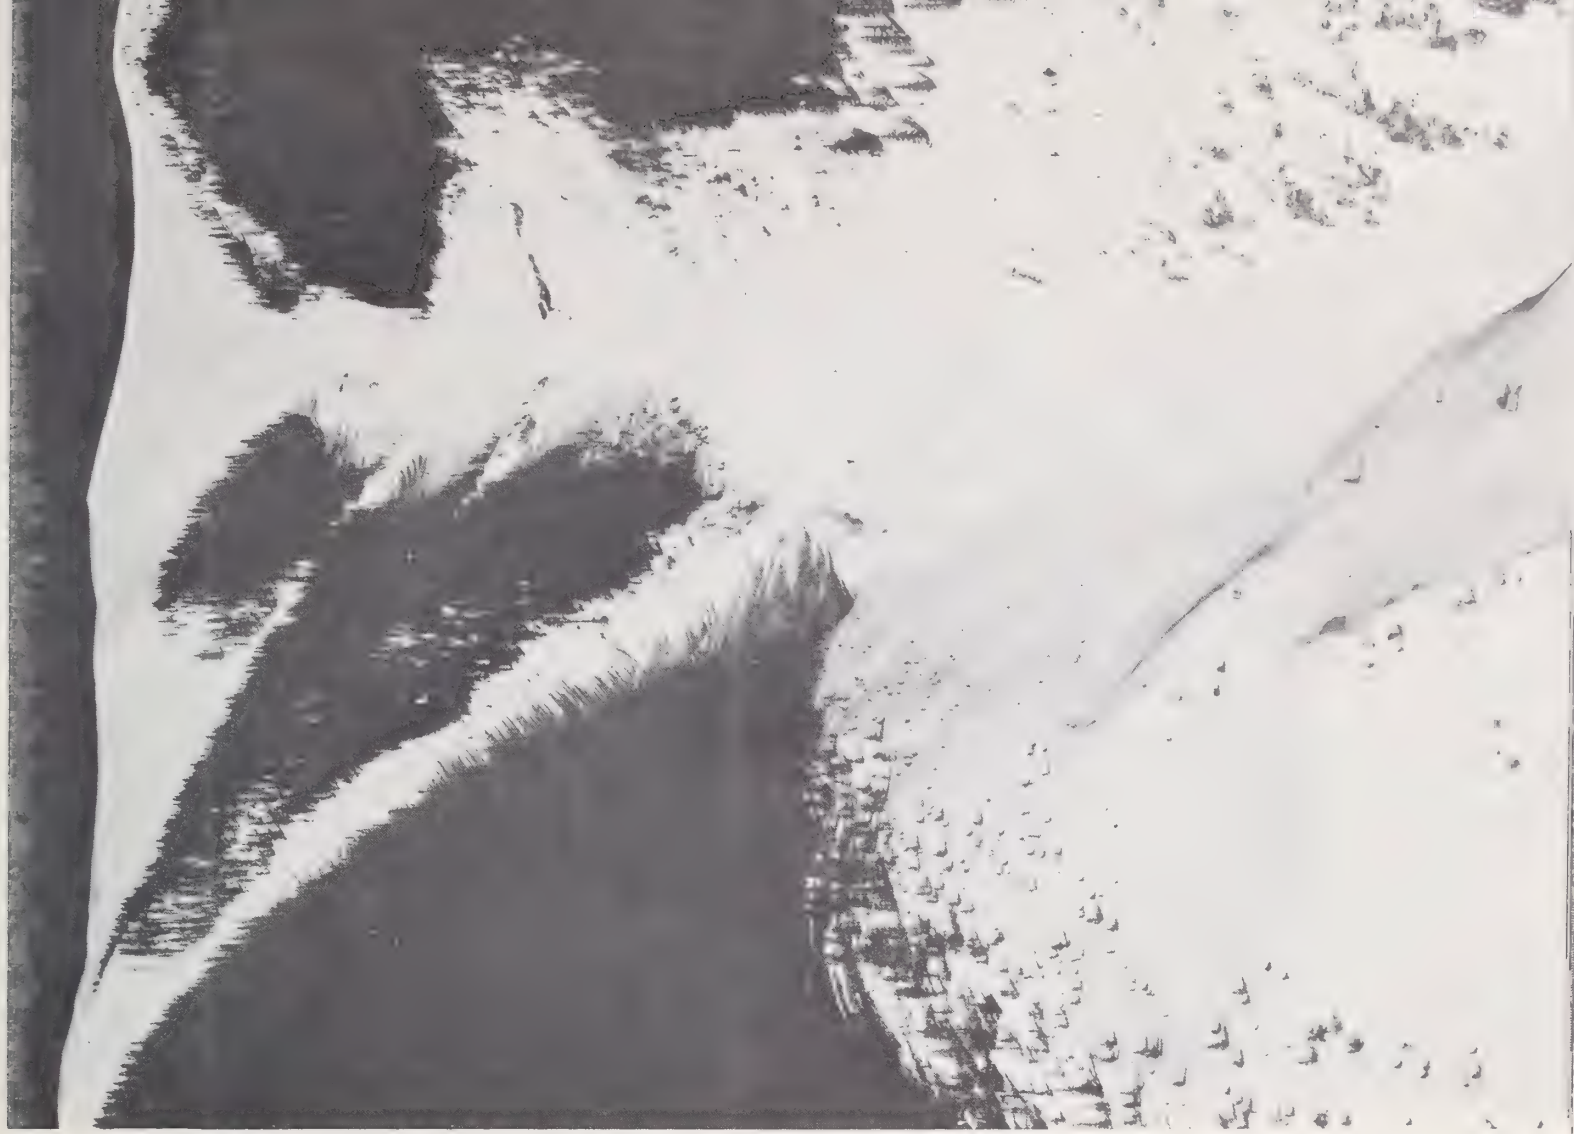
IMOGENE (R-9)

Highway No. 550 --
Red Mountain Pass
Photo: March 25, 1962

Supporting structures and afforestation.

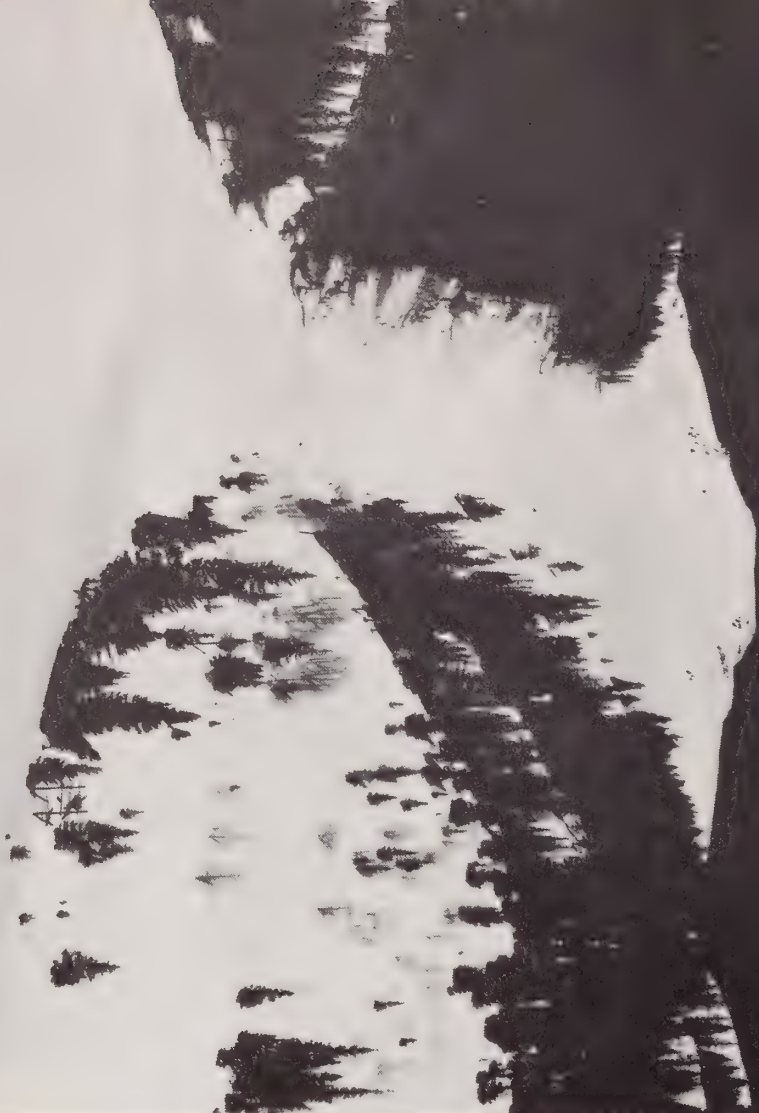
BROOKLYNS (R-10)

Highway No. 550 --
Red Mountain Pass
Photo: January 3, 1962

Although the rugged top of starting zones and scree slopes give some problems, control by supporting structures is possible for a considerable number of the tracks.

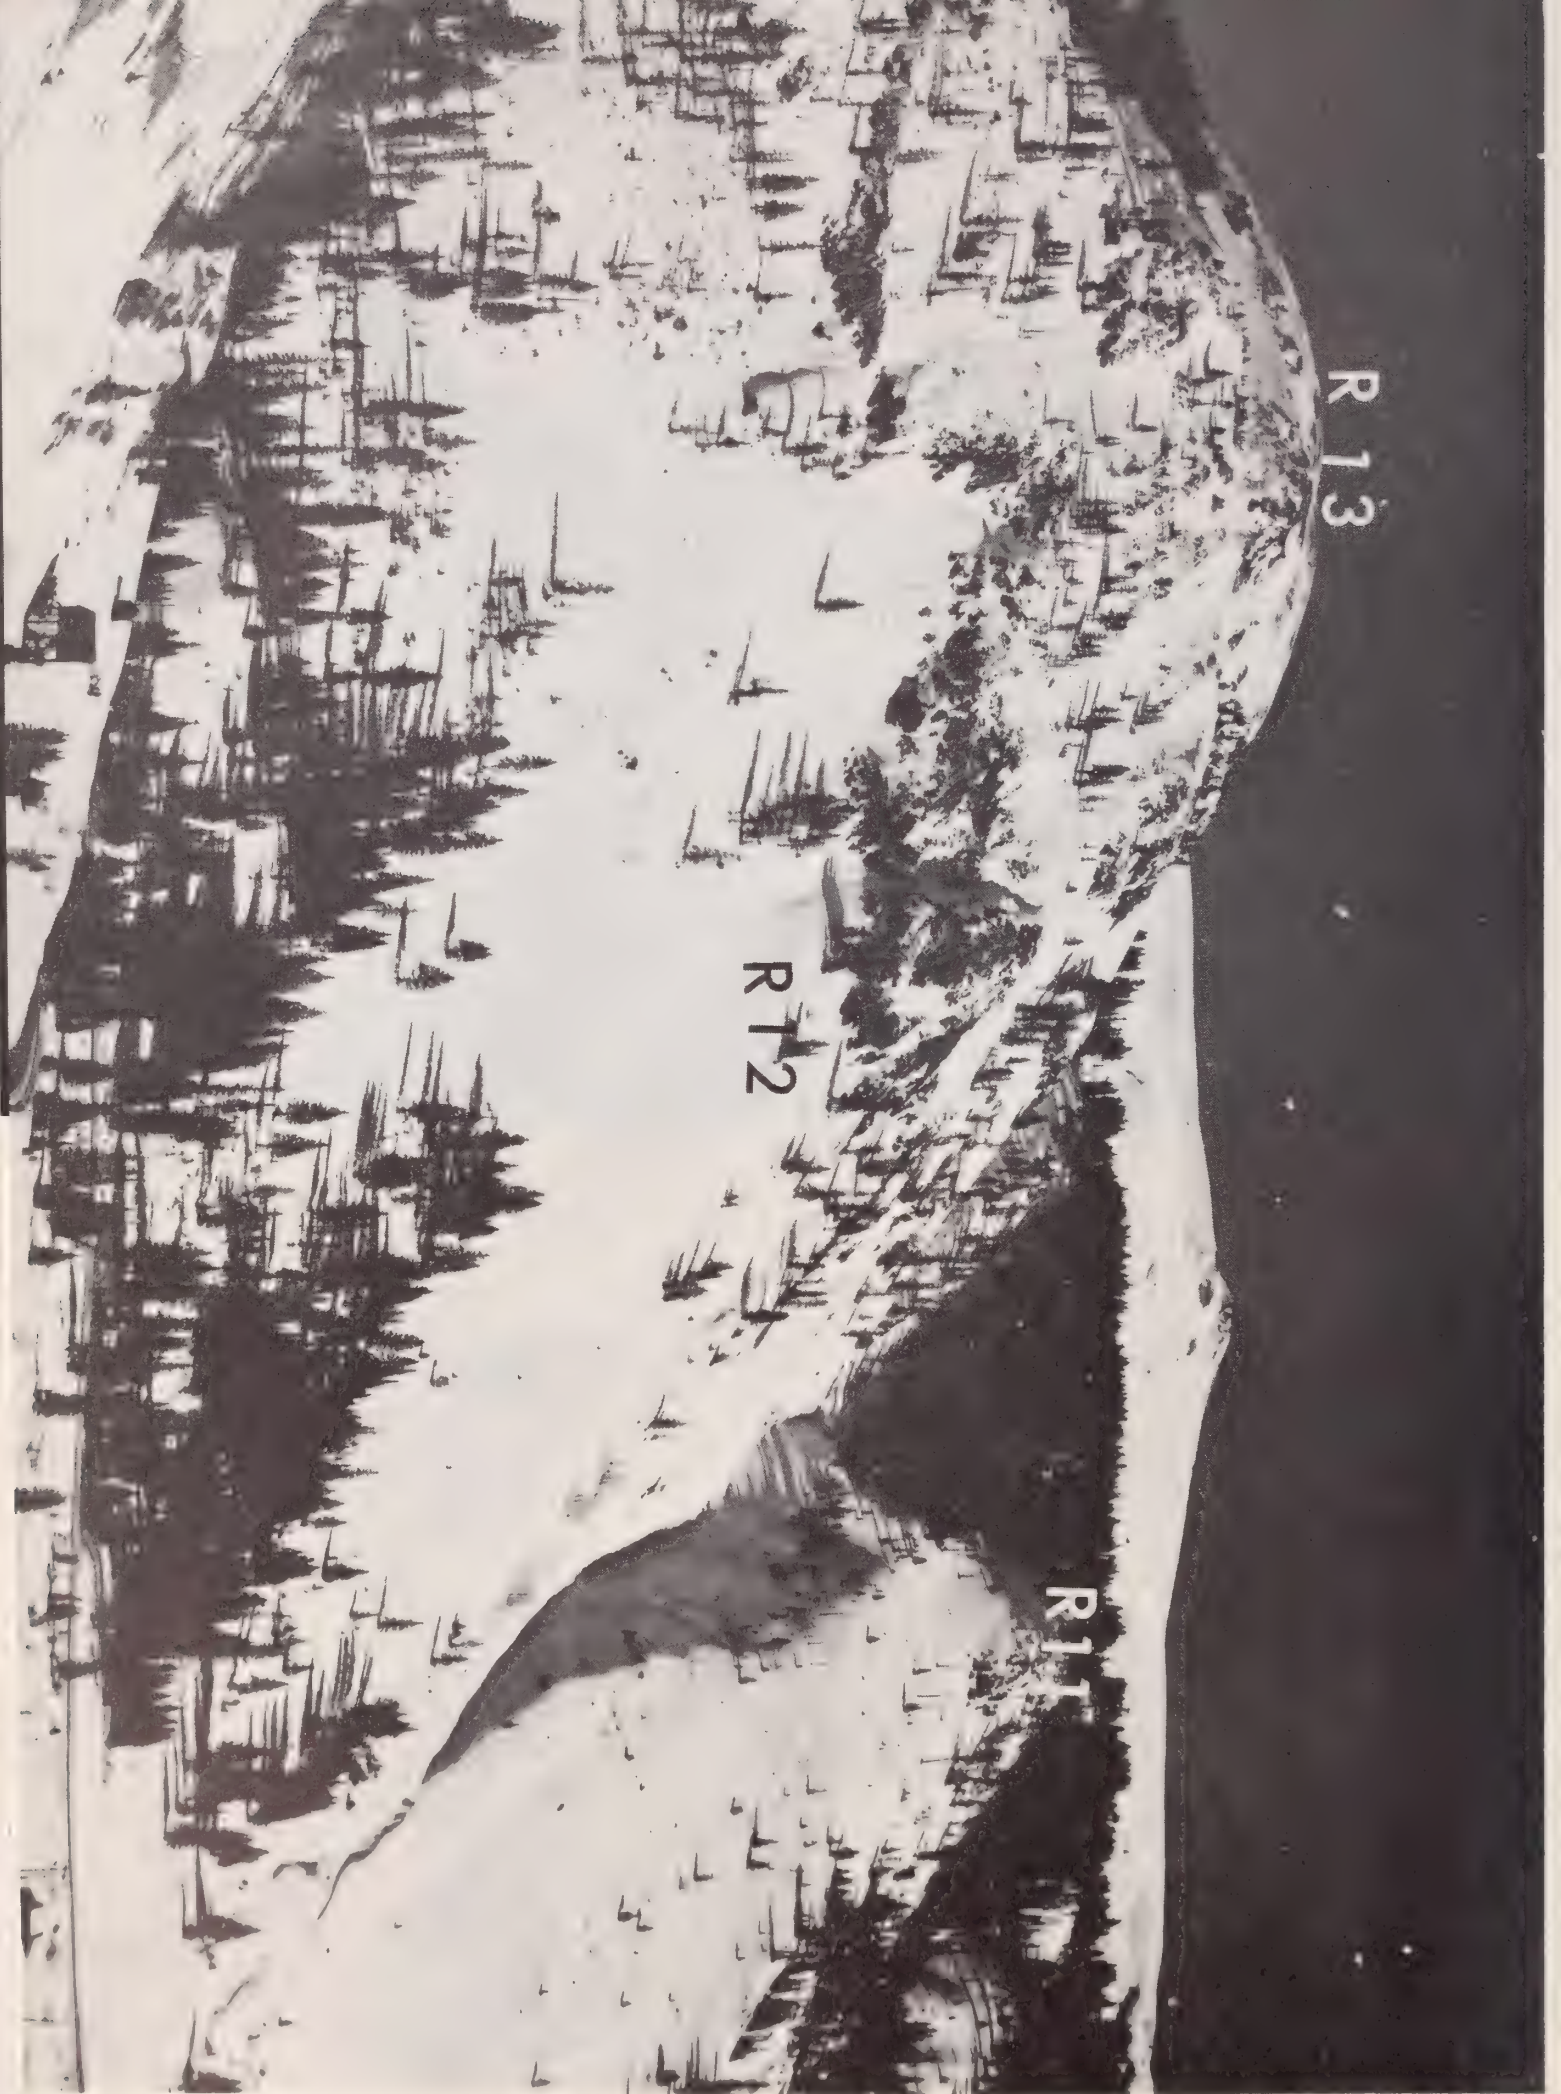
CEMETERY (R-11)

Highway No. 550 --
Red Mountain Pass
Photo: January 3, 1962

Supporting structures not recommended because of rugged starting zone; retarding structures might be possible.

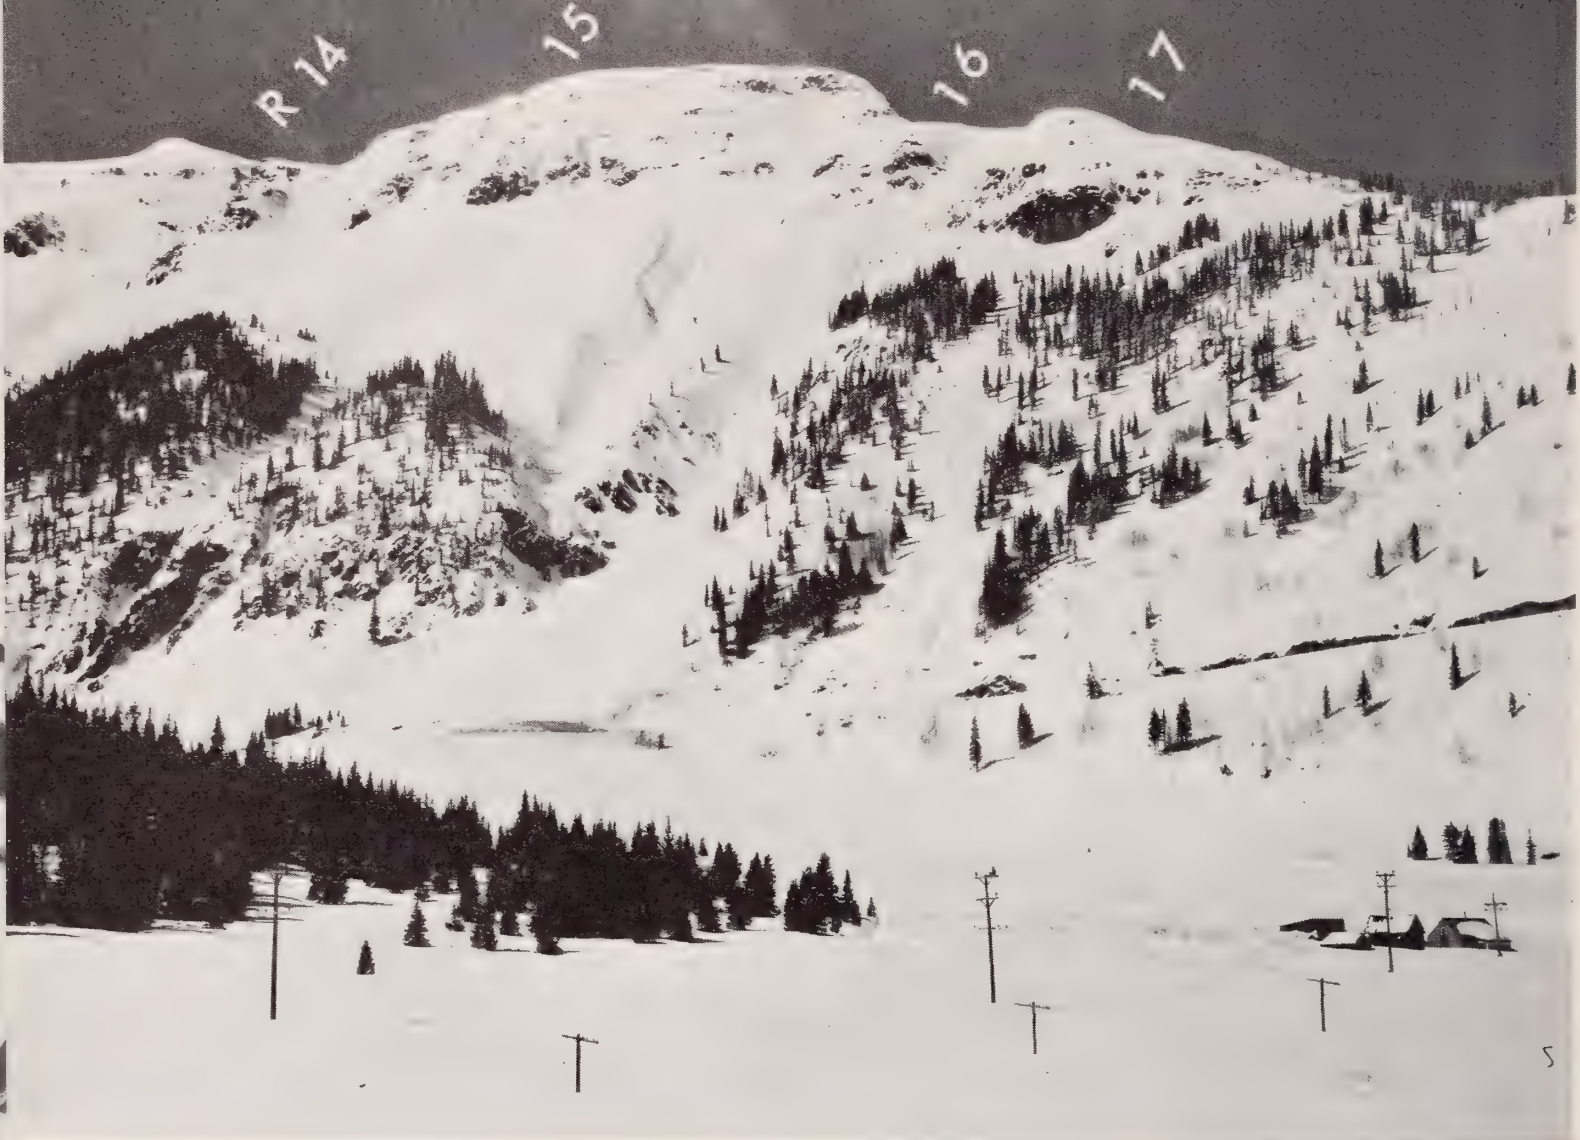
MULESHOE (R-14)

Highway No. 550 --
Red Mountain Pass
Photo: March 24, 1962
